El Paso Building
1001 Louisiana Street

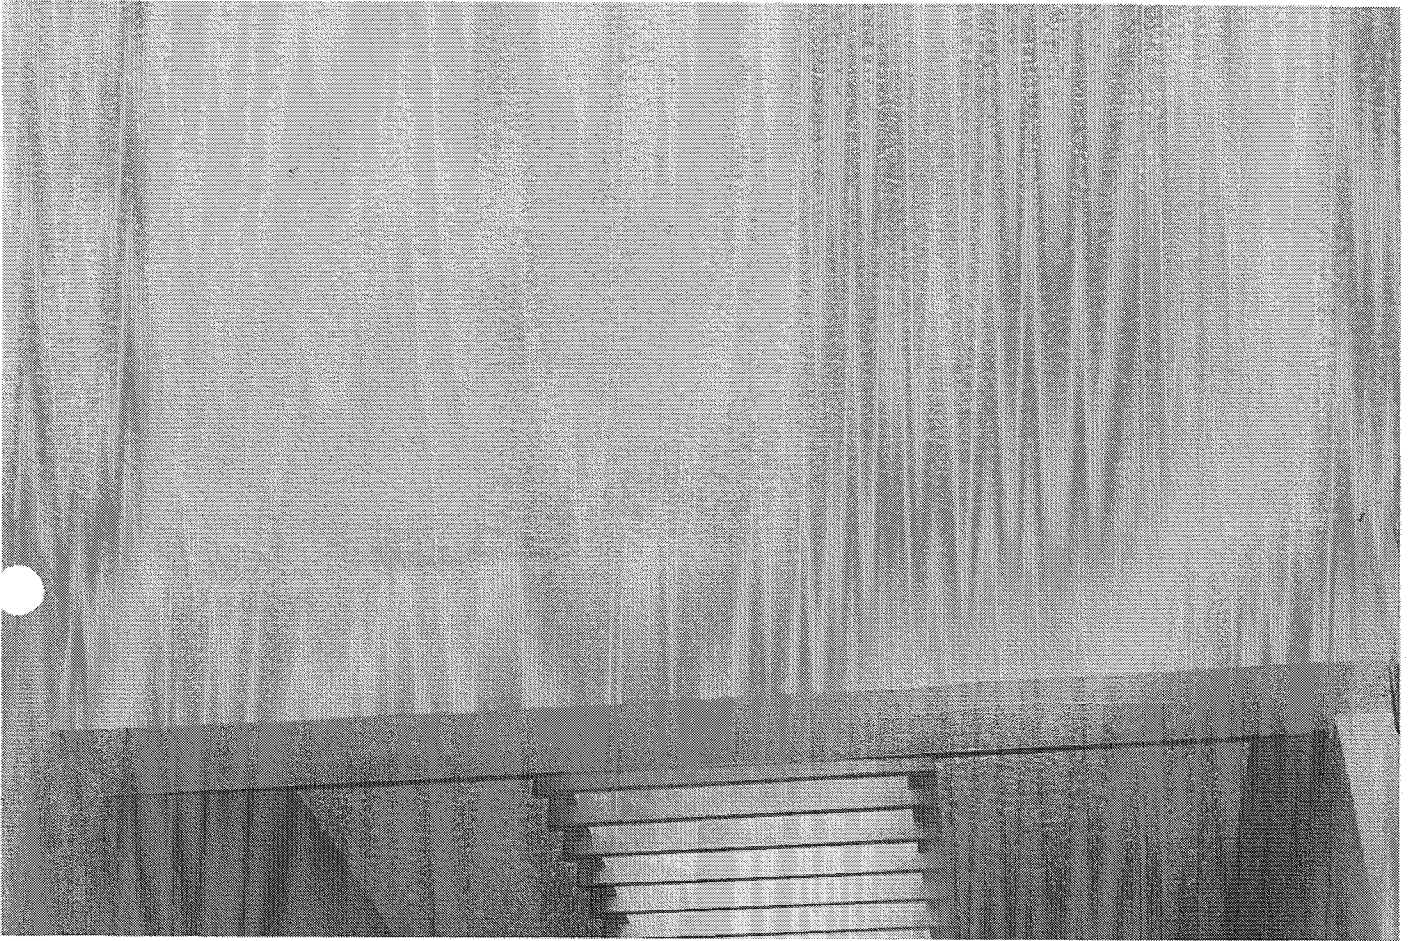
12. 2nd floor, hallway outside offices - View of water damaged acoustical plaster

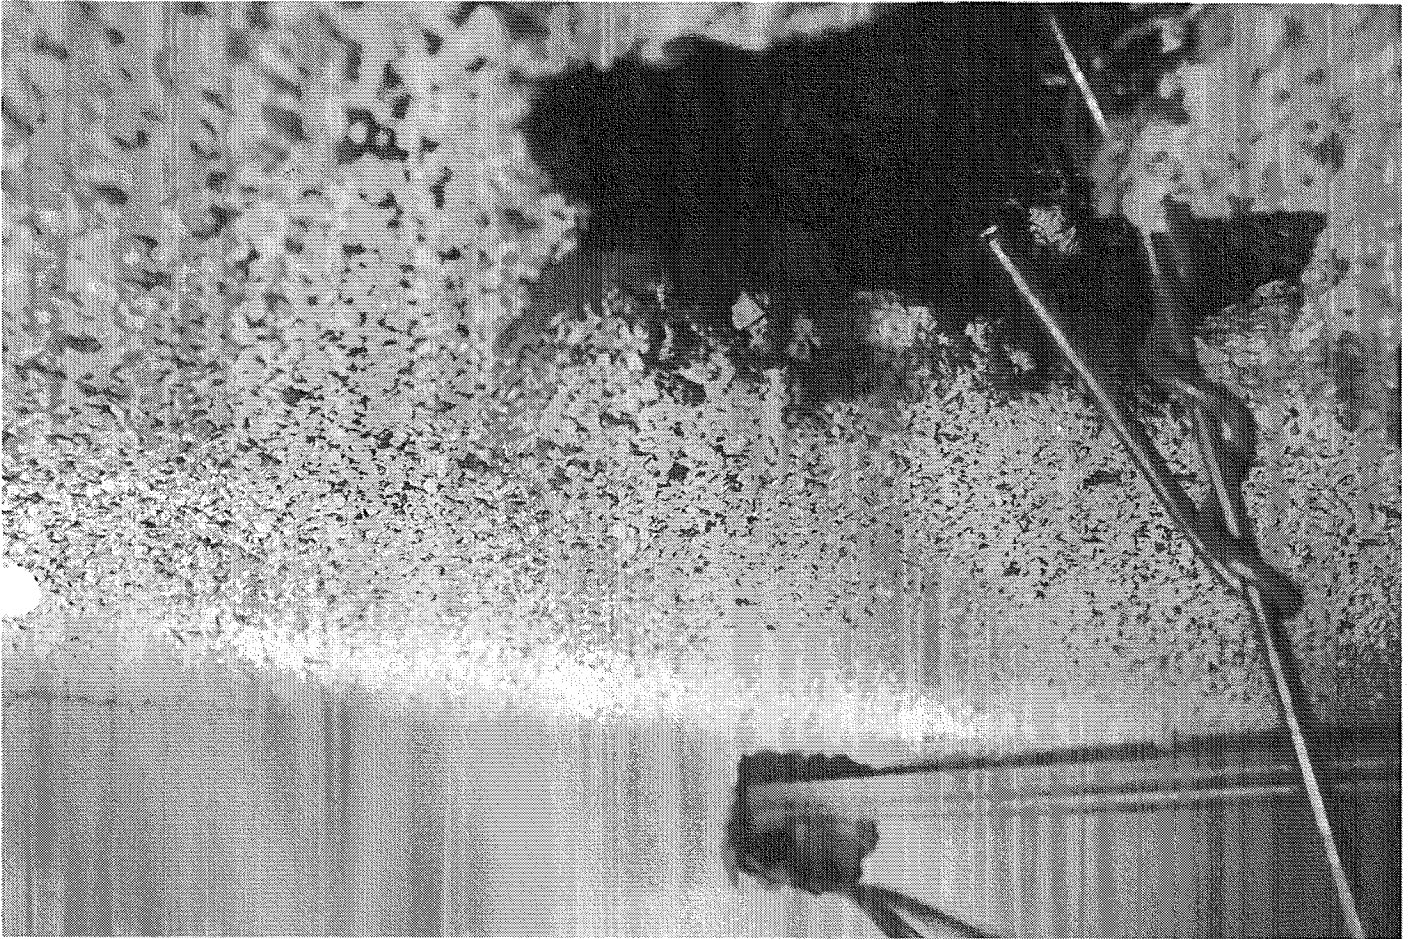
13. 2nd floor, hallway and copy area - Close-up of damaged acoustical plaster (note: fibrous nature of material)

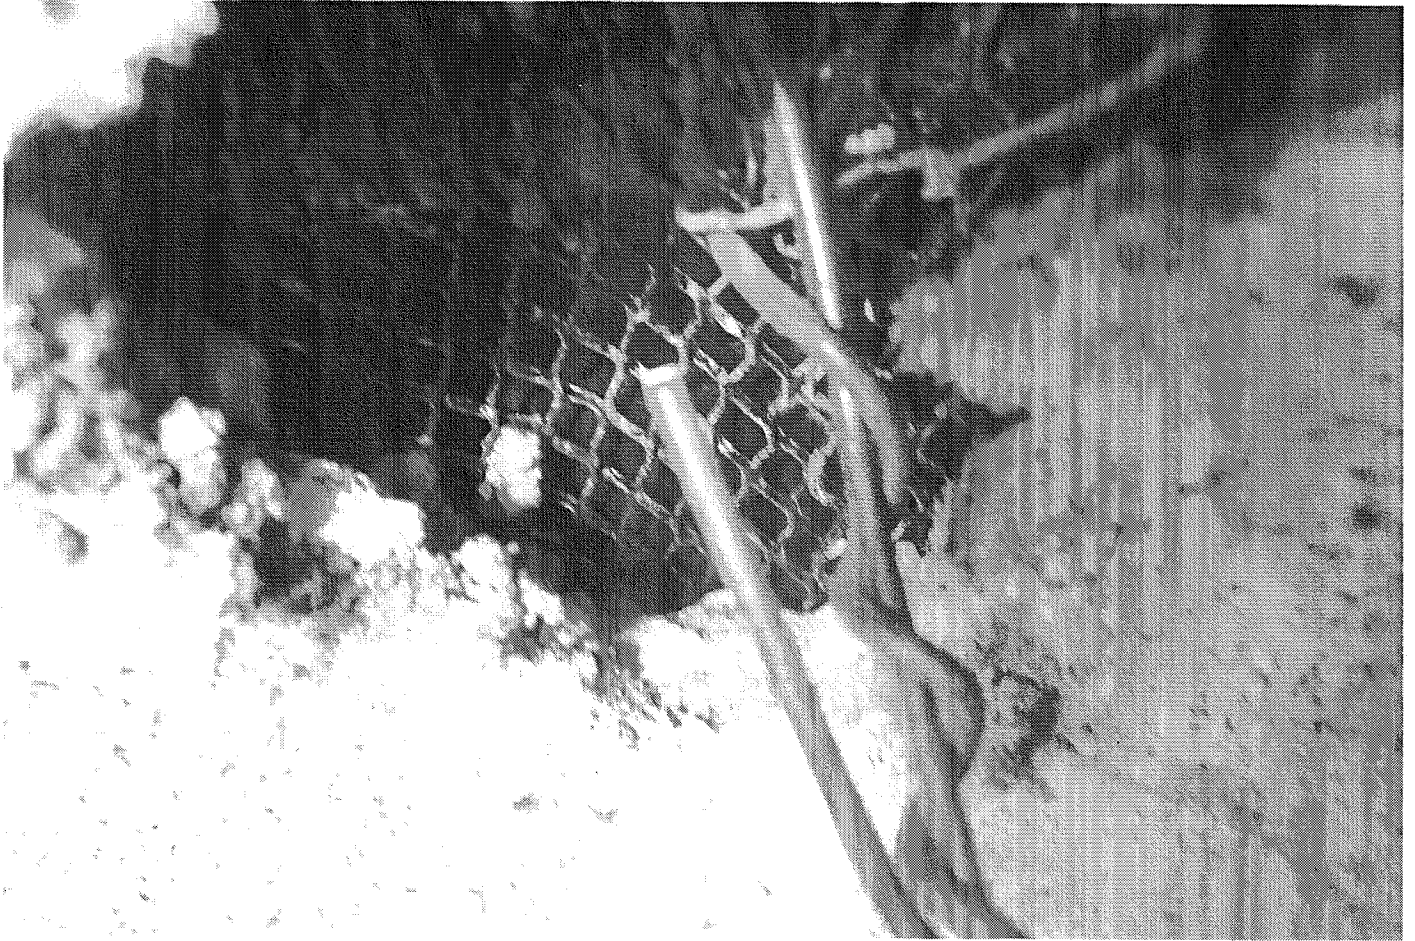
14. 2nd floor, hallway and copy area - Close-up of damaged acoustical plaster (note: fibrous nature of material)
